Memorandum

Date: *August 15, 2014*

Subject: *Oversight Summary Report
CPG Oversight of RM 10.9 Removal Action
Lower Passaic River Restoration Project*

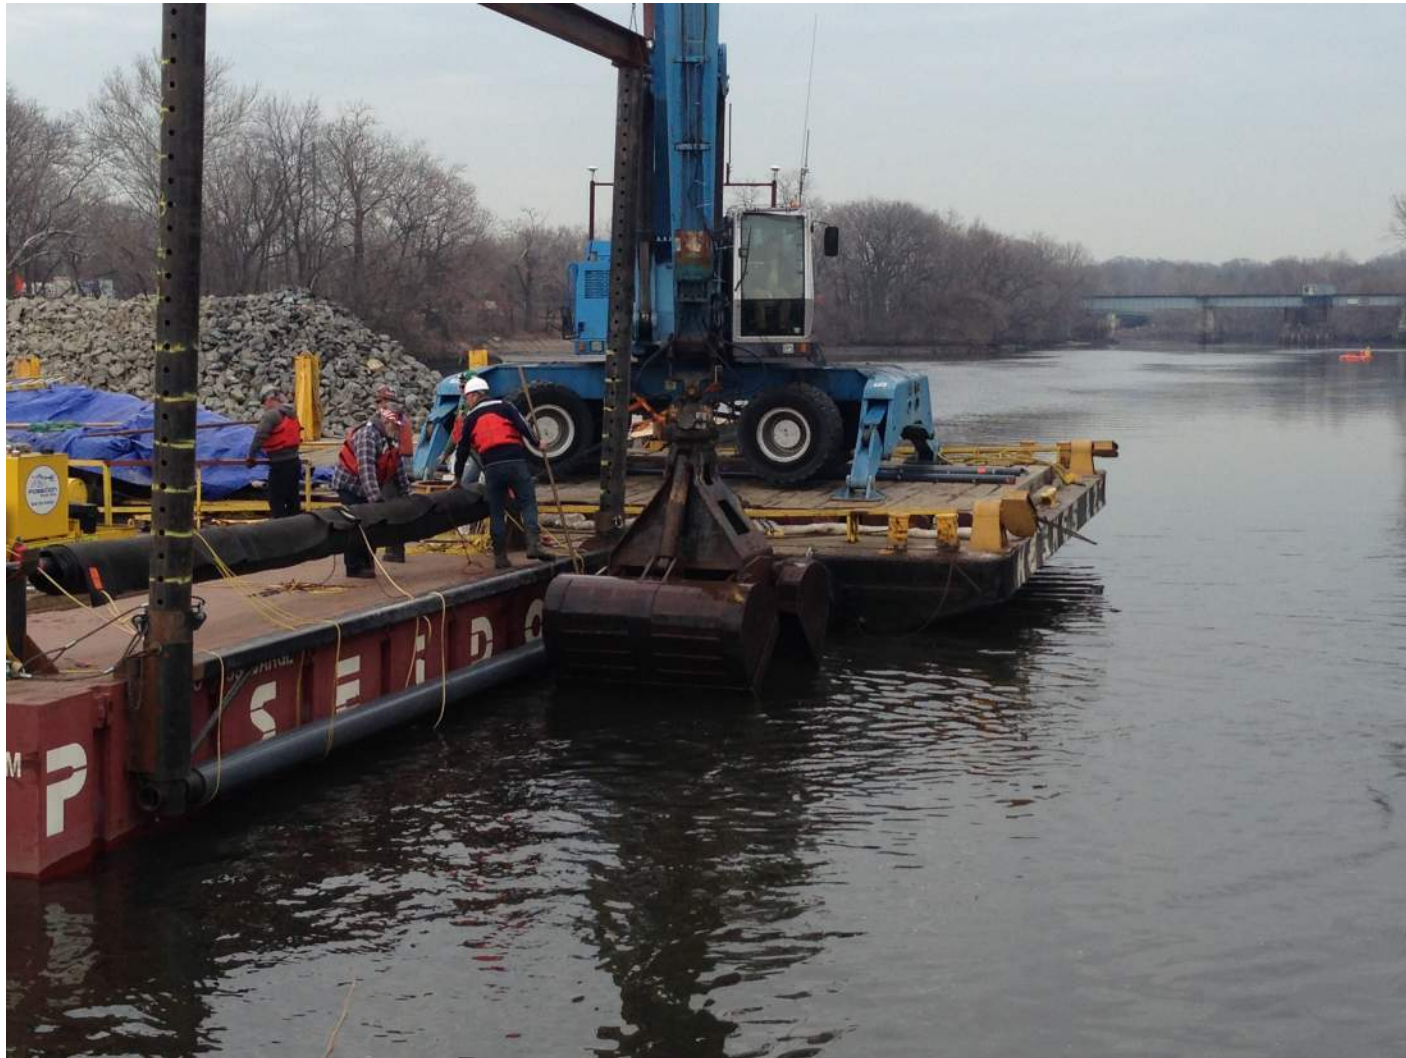
Panel 23-N Repositioning

GLDD hooked the exposed, folded-over edge of panel 23-N and pulled it upward. There was a strong ebb tide that then unfolded the fabric by carrying it to the south. They threw sand bags to keep the edge in position before installing panel 22-N.

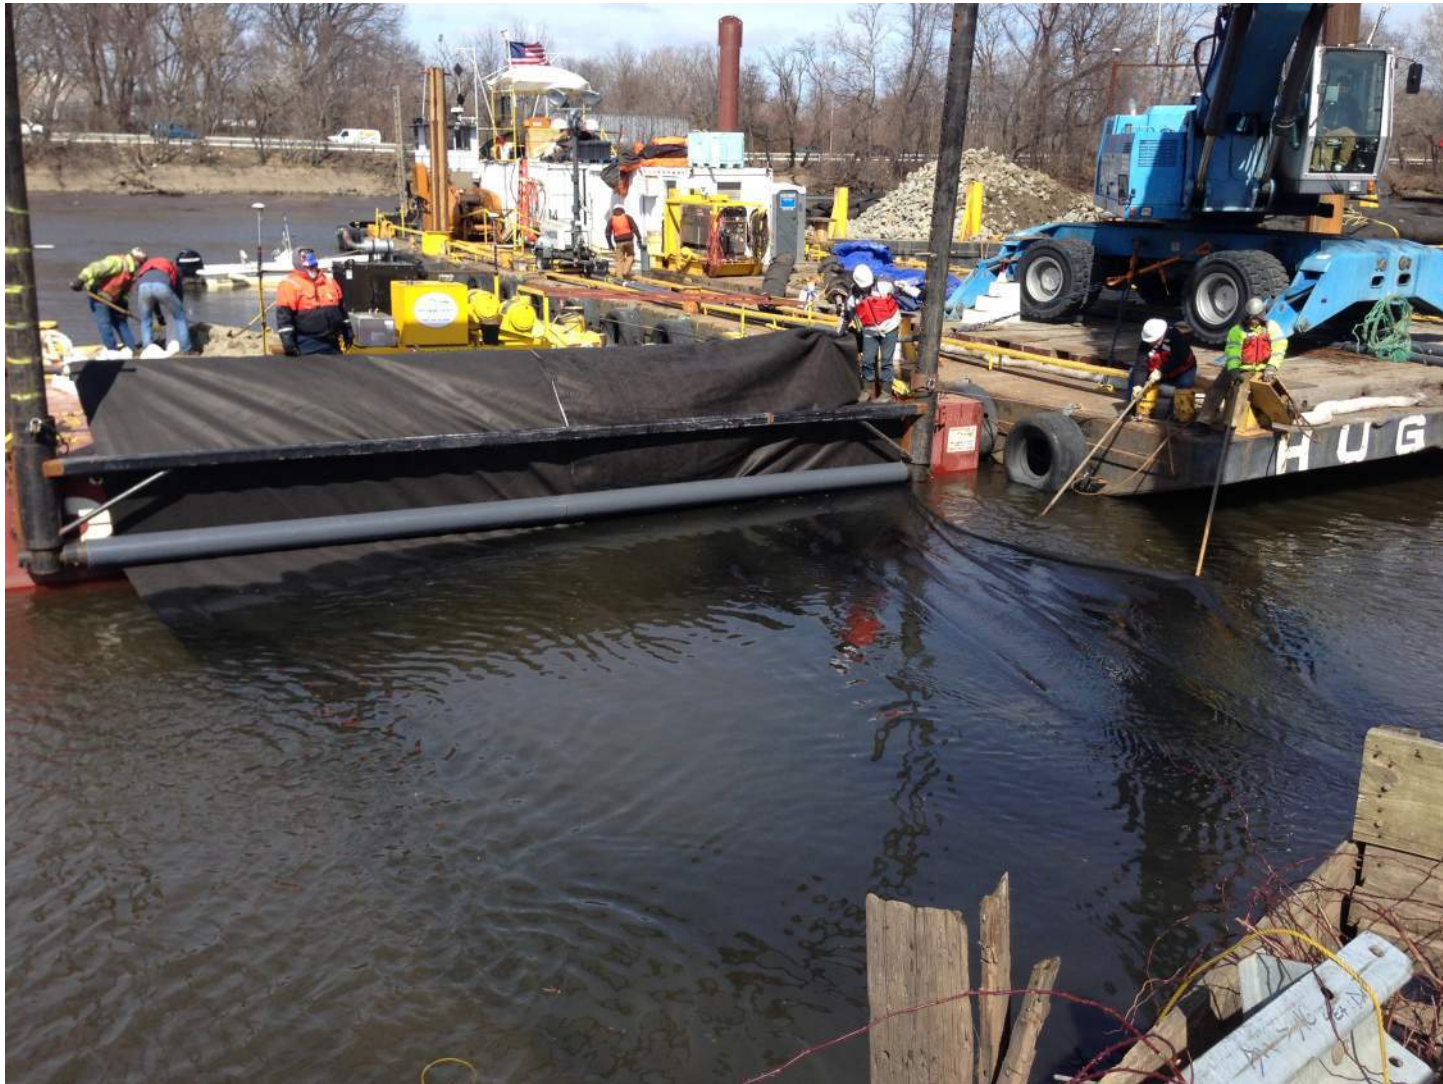
Panel 20-N Installation

GLDD installed geotextile panel 20-N this afternoon. They are approaching the fire department boat launch, moving from north to south.

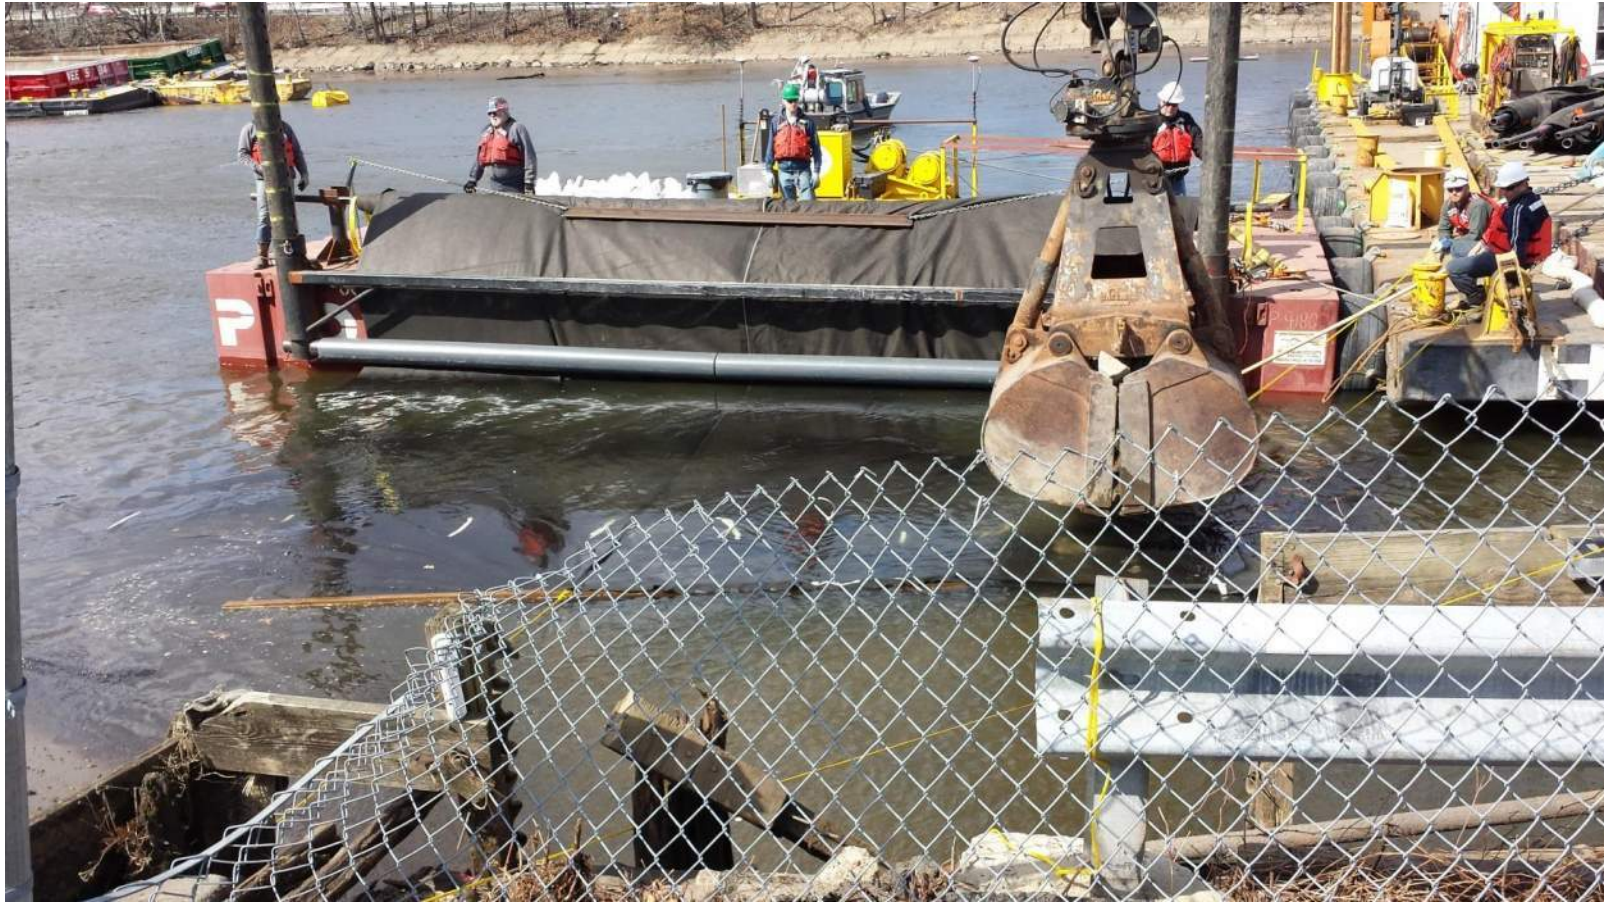
Panel 17-N Installation

GLDD beginning to lay armor stone on top of panel 17-N.

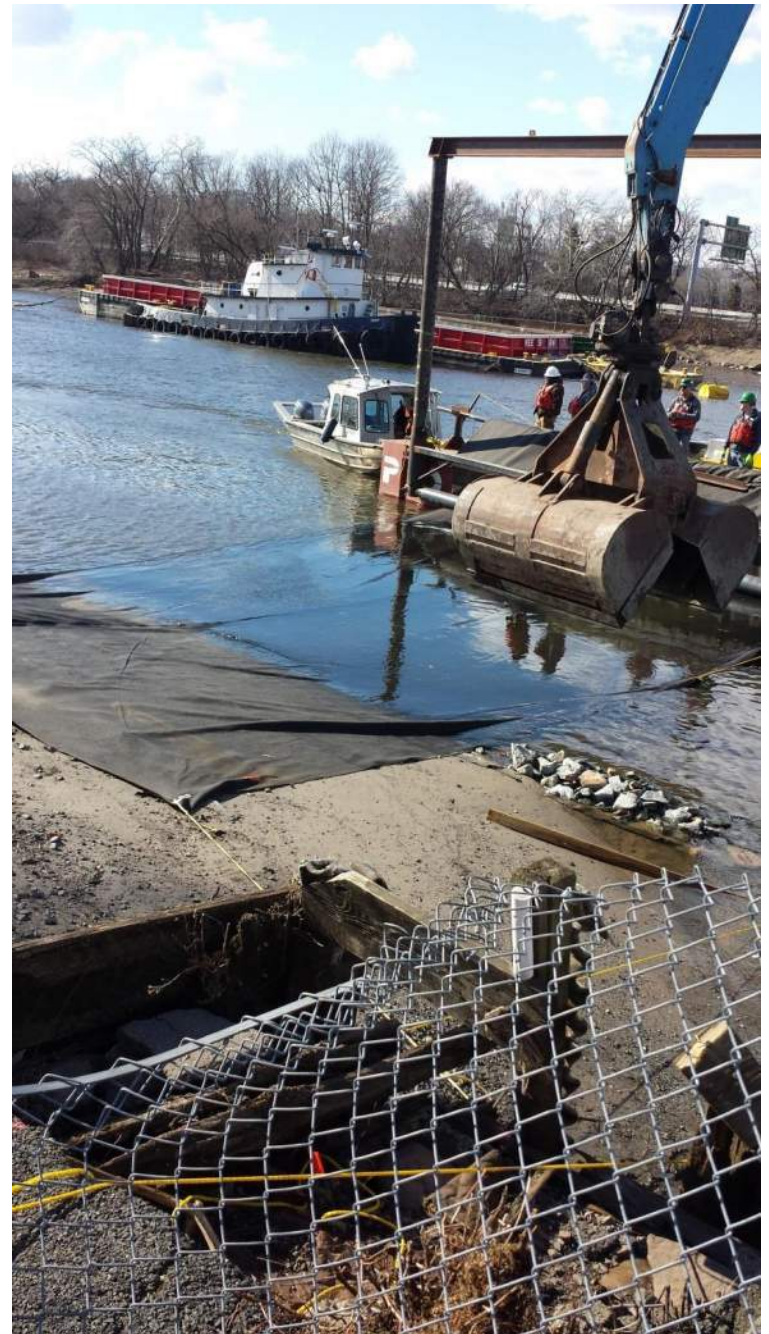
Panel 16-N Installation

GLDD laying armor stone on top panel 16-N. Good overlap is observed.

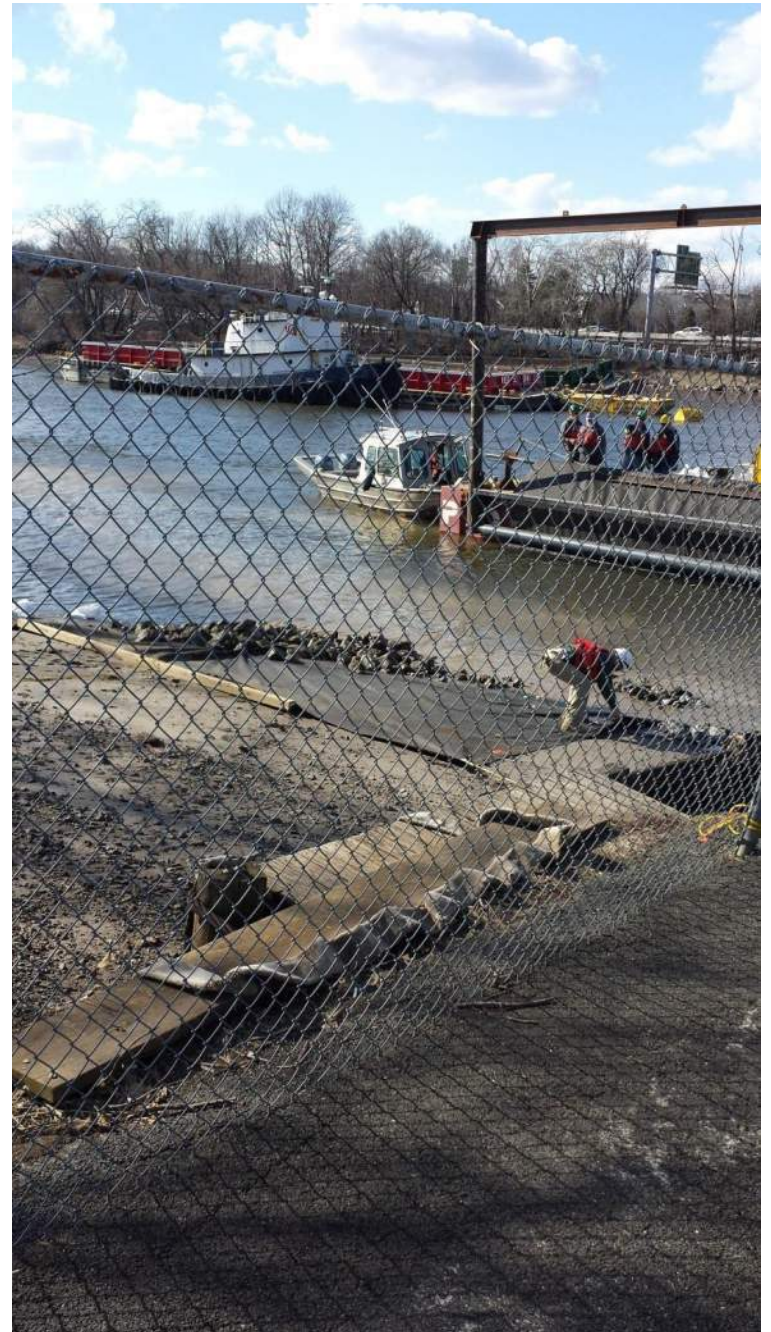
Trimming Panel 16-N

GLDD is trimming the top corner of panel 16-N to meet the design criteria.

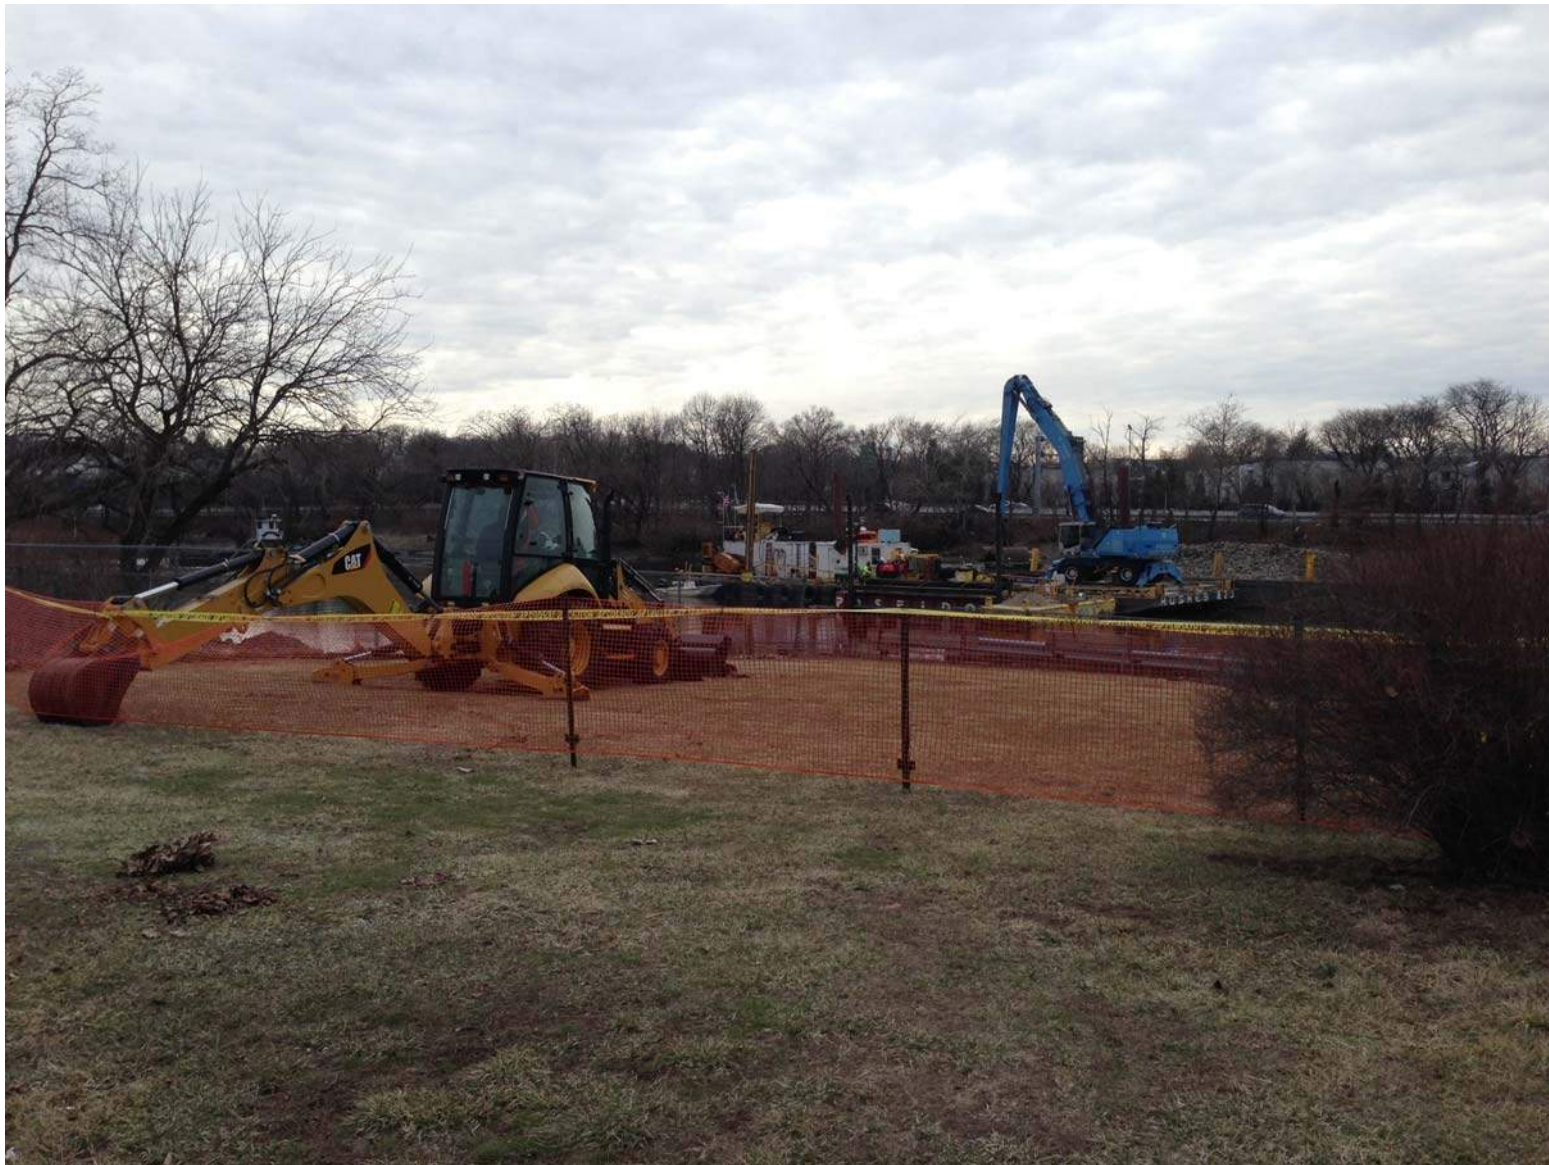
Backhoe Anchor

A winch system is now being used to move the main barge. It is anchored at two points on the shore, one of which is the backhoe shown above.

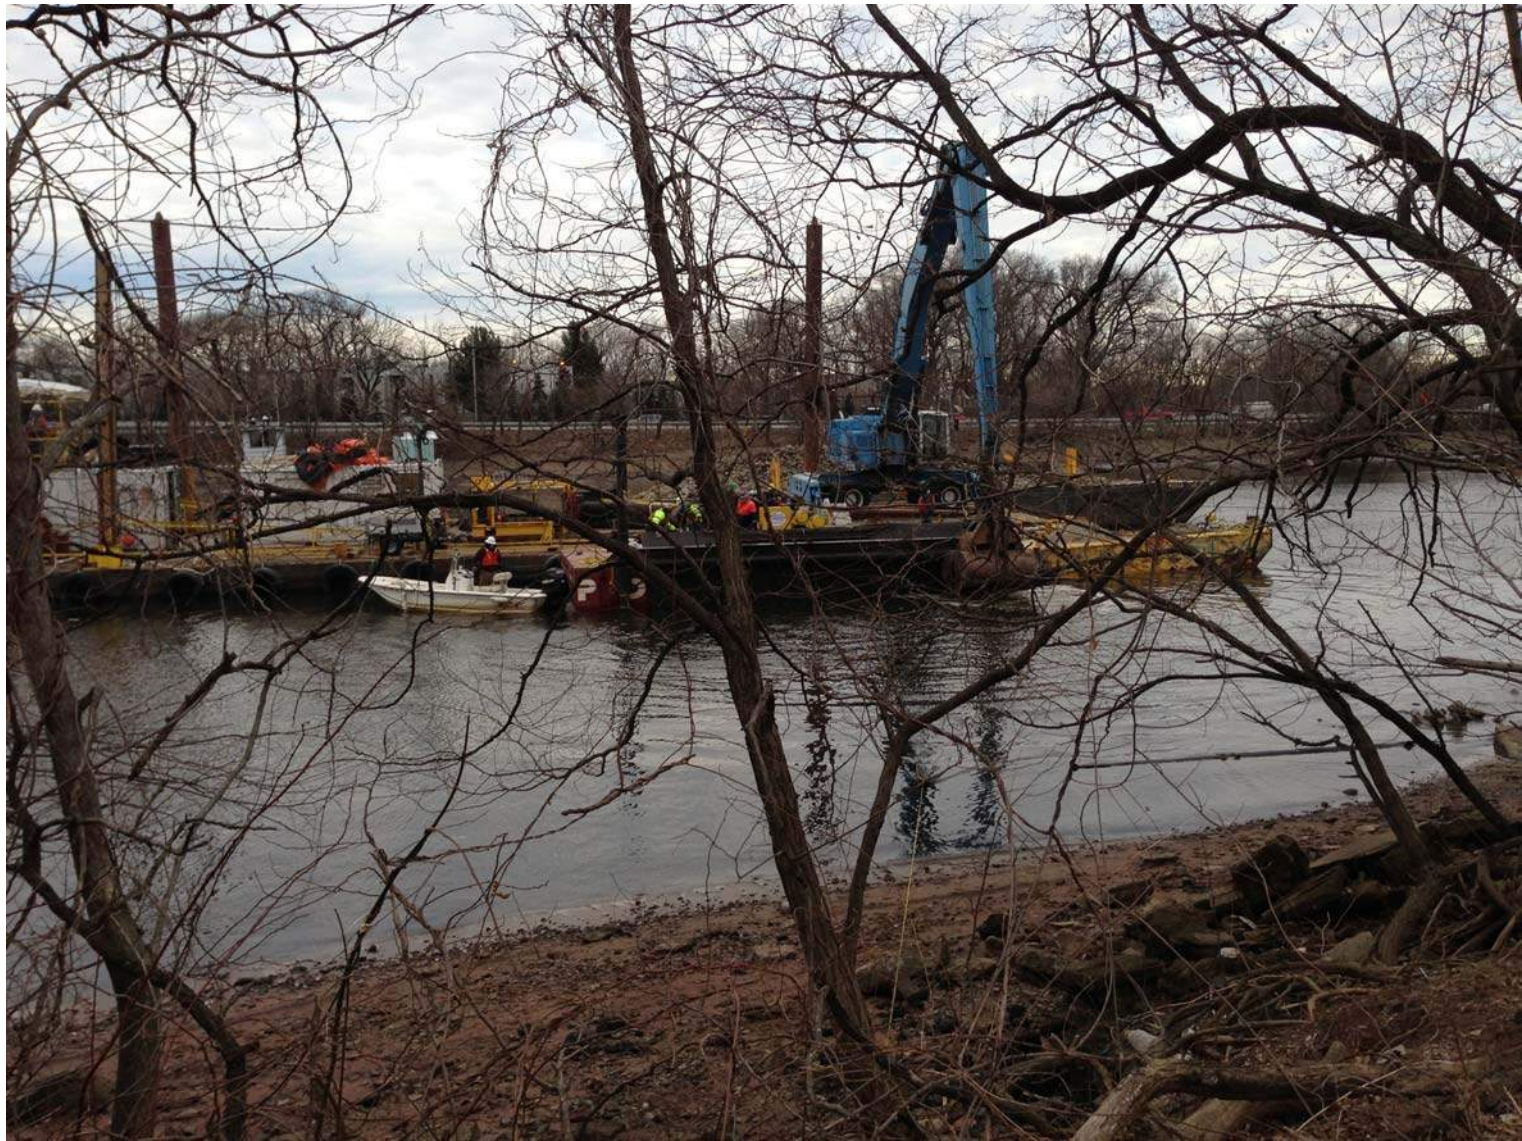
Panel 14-N Installation

With the new setup, the Poseidon barge is oriented parallel to the main barge rather than perpendicular beside it.

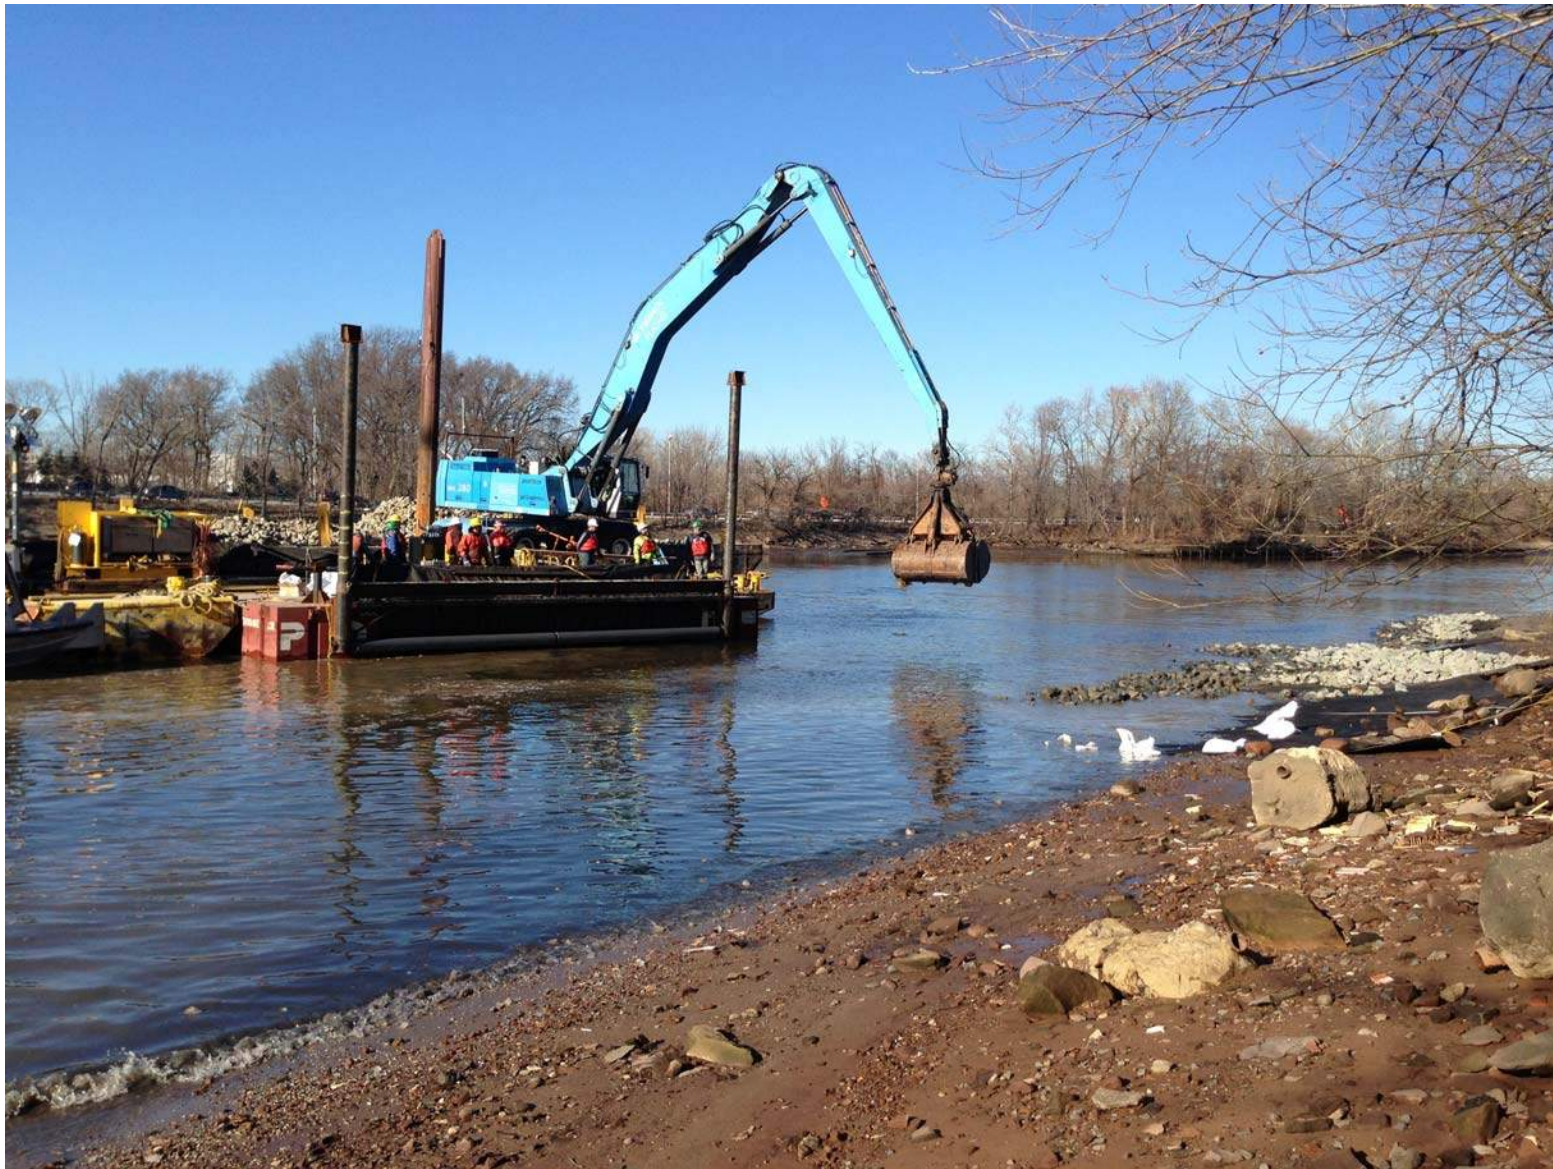
Panel 12-N Installation

Panel 12-N is approximately 120 feet long. Installation took about an hour but had to be performed during the slack tide to avoid interference from the current.

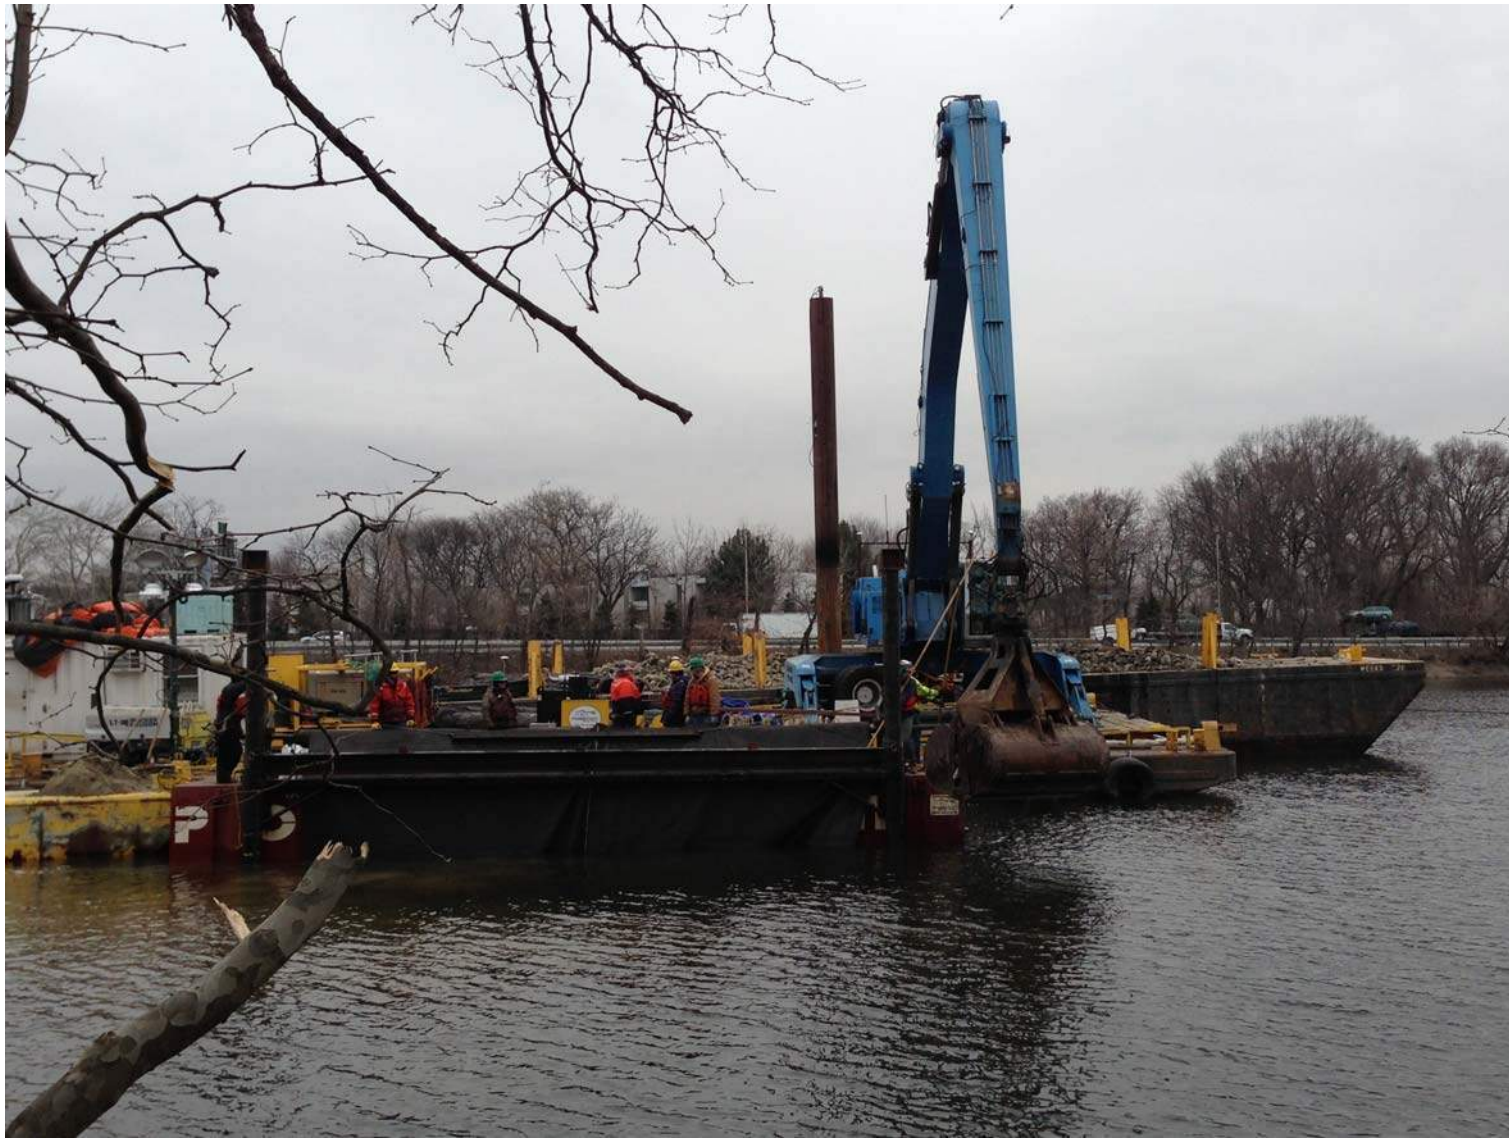
Panel 11-N Installation

Panel 11-N was installed in slightly over an hour. The excavator operator also completed installing rock on adjacent Panel 12-N.

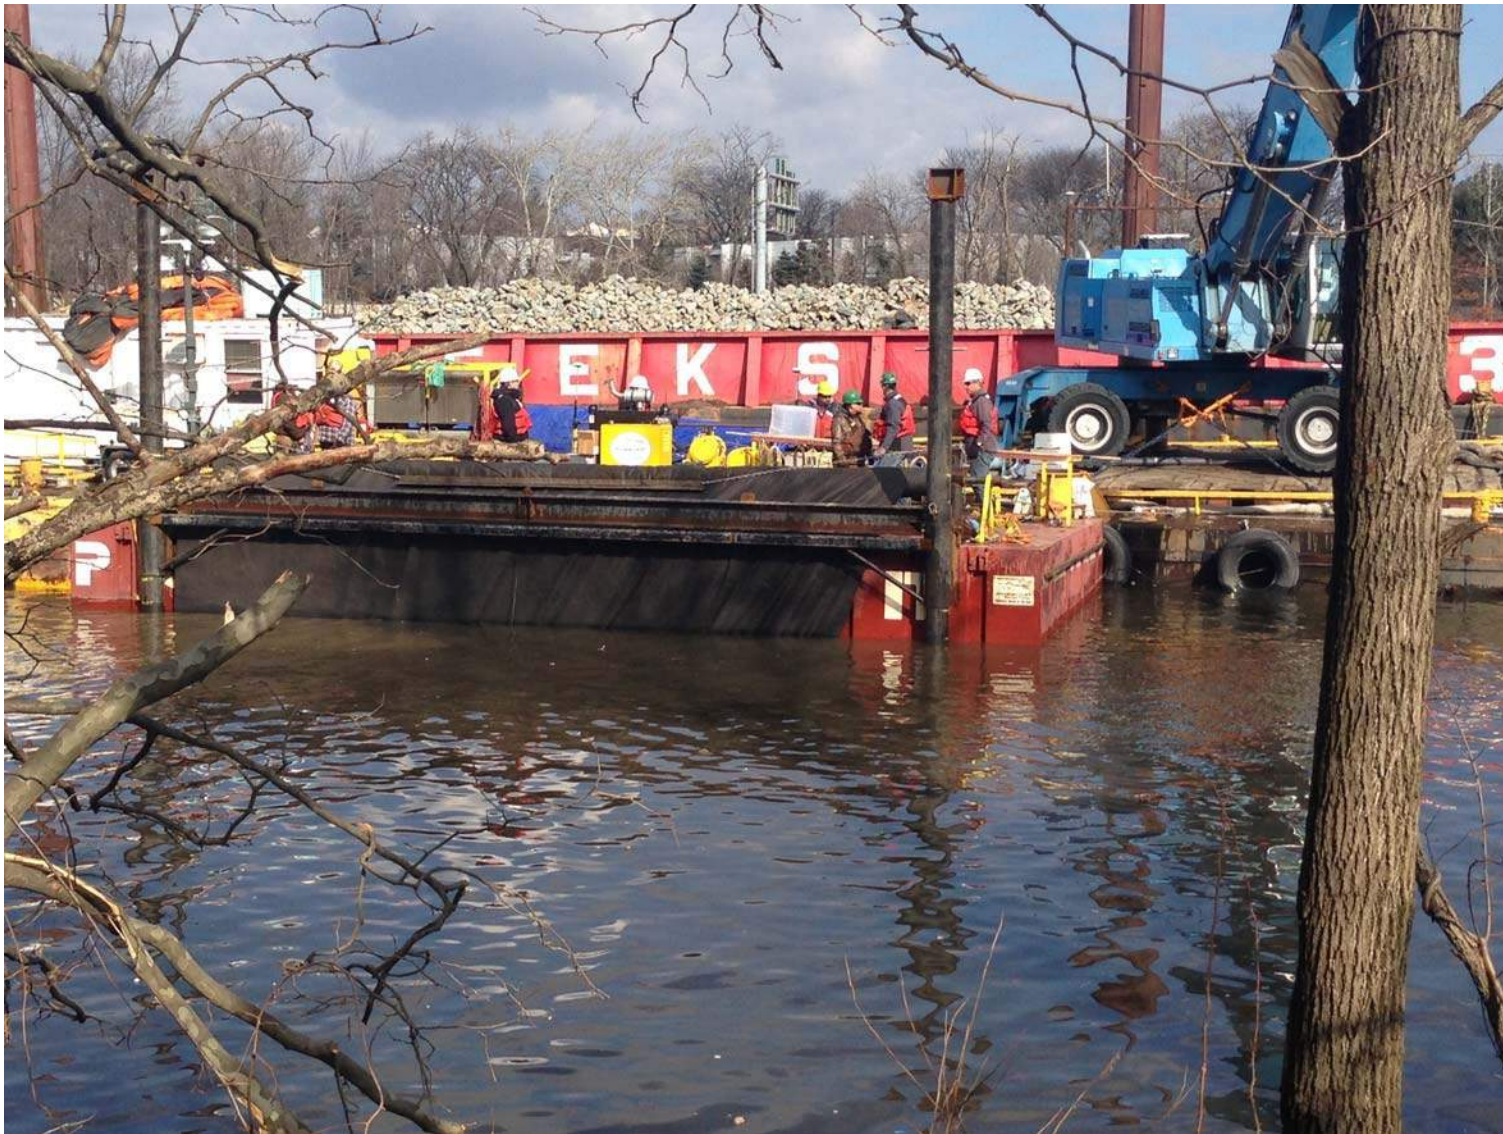
Panel 10-N Installation

Panel 10-N was installed in the morning. With the new barge setup (using the winch system) GLDD are having slightly more difficulty maintaining the position of the fabric at its northern edge, as pictured above.

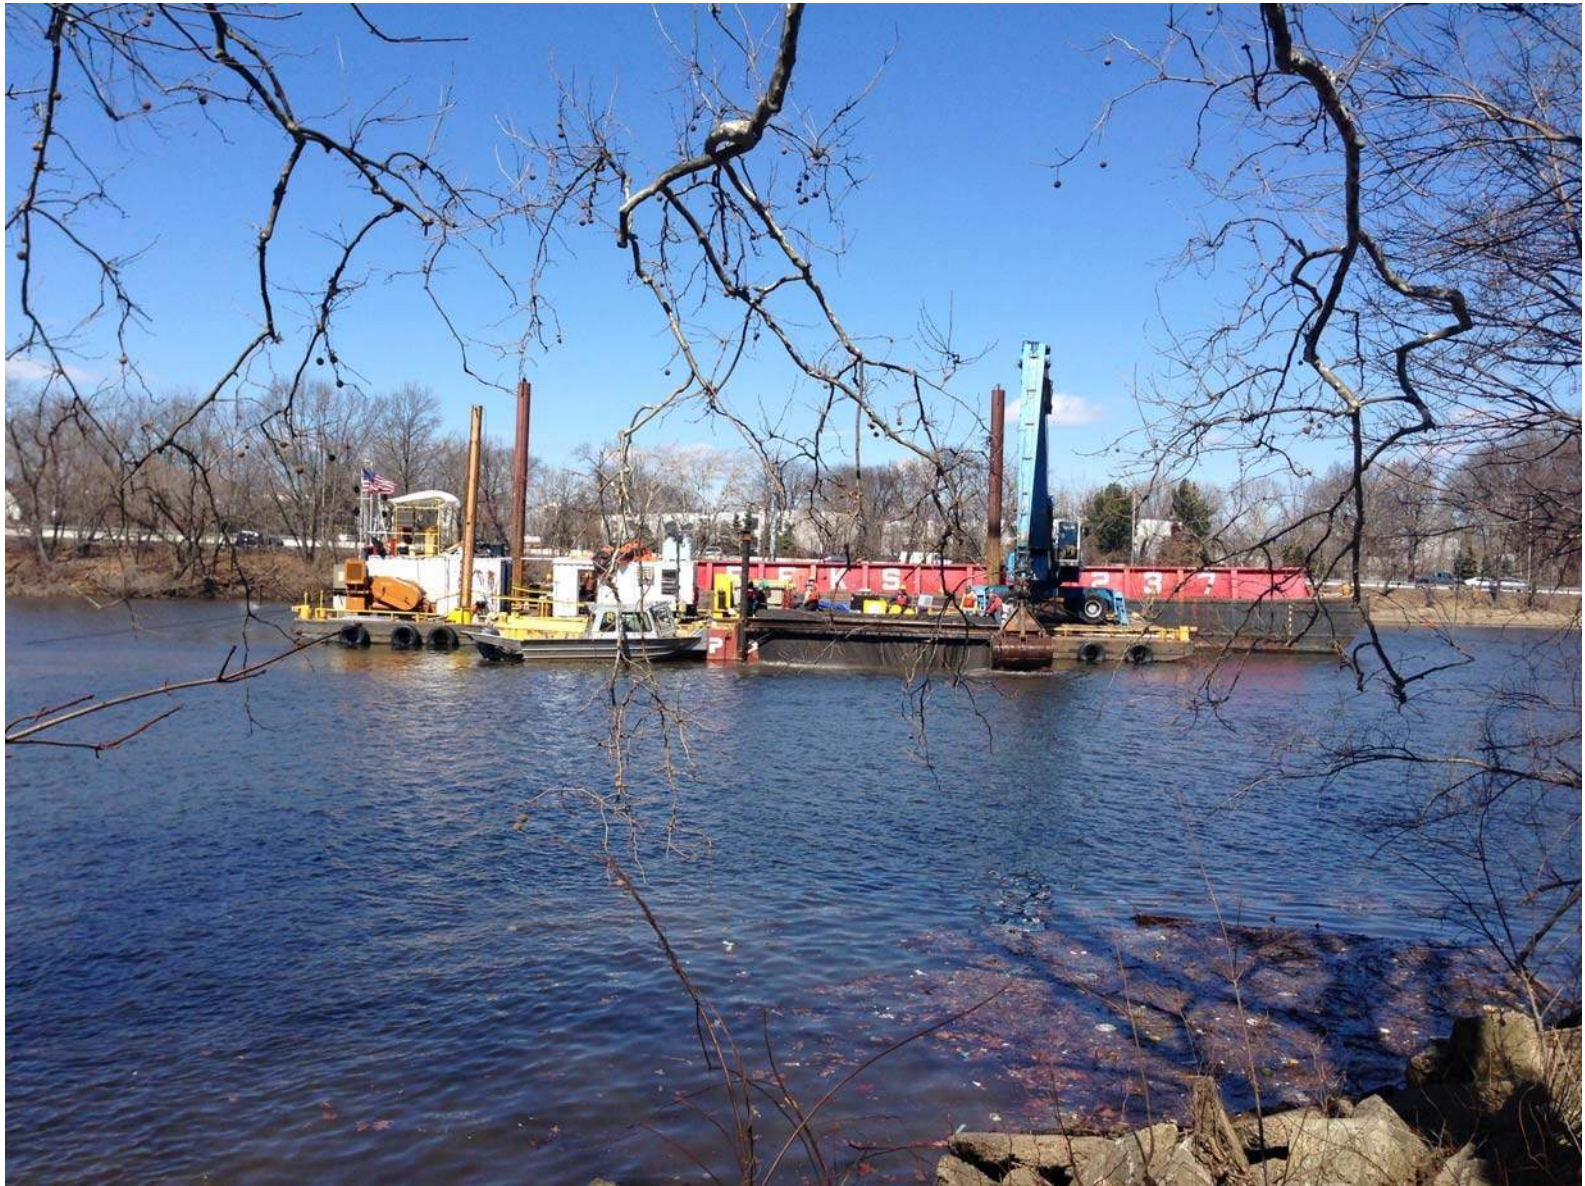
Panel 8-N Installation

This panel was well over 100 feet in length and installation took about one hour.

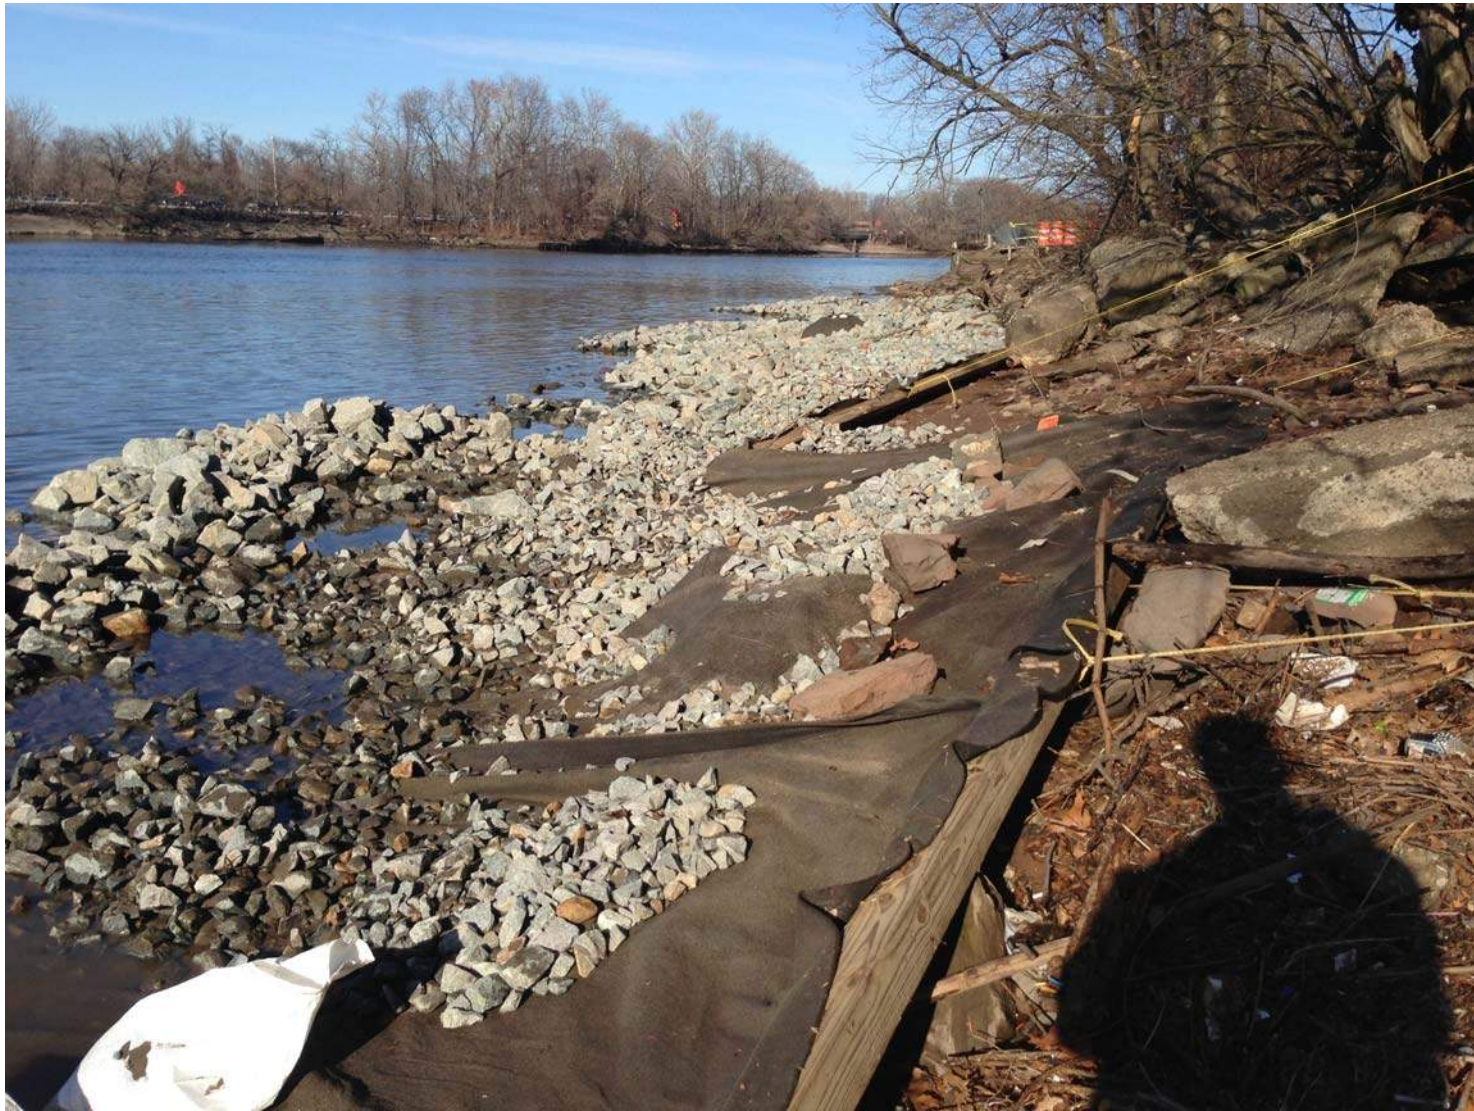
Type B Armor Stone

The Type B armor stone is visible at low tide on the edges of panels 10-N, 9-N and 8-N. GLDD may need to return to panels N-14 through N-17 to apply the Type B stone near the shore.

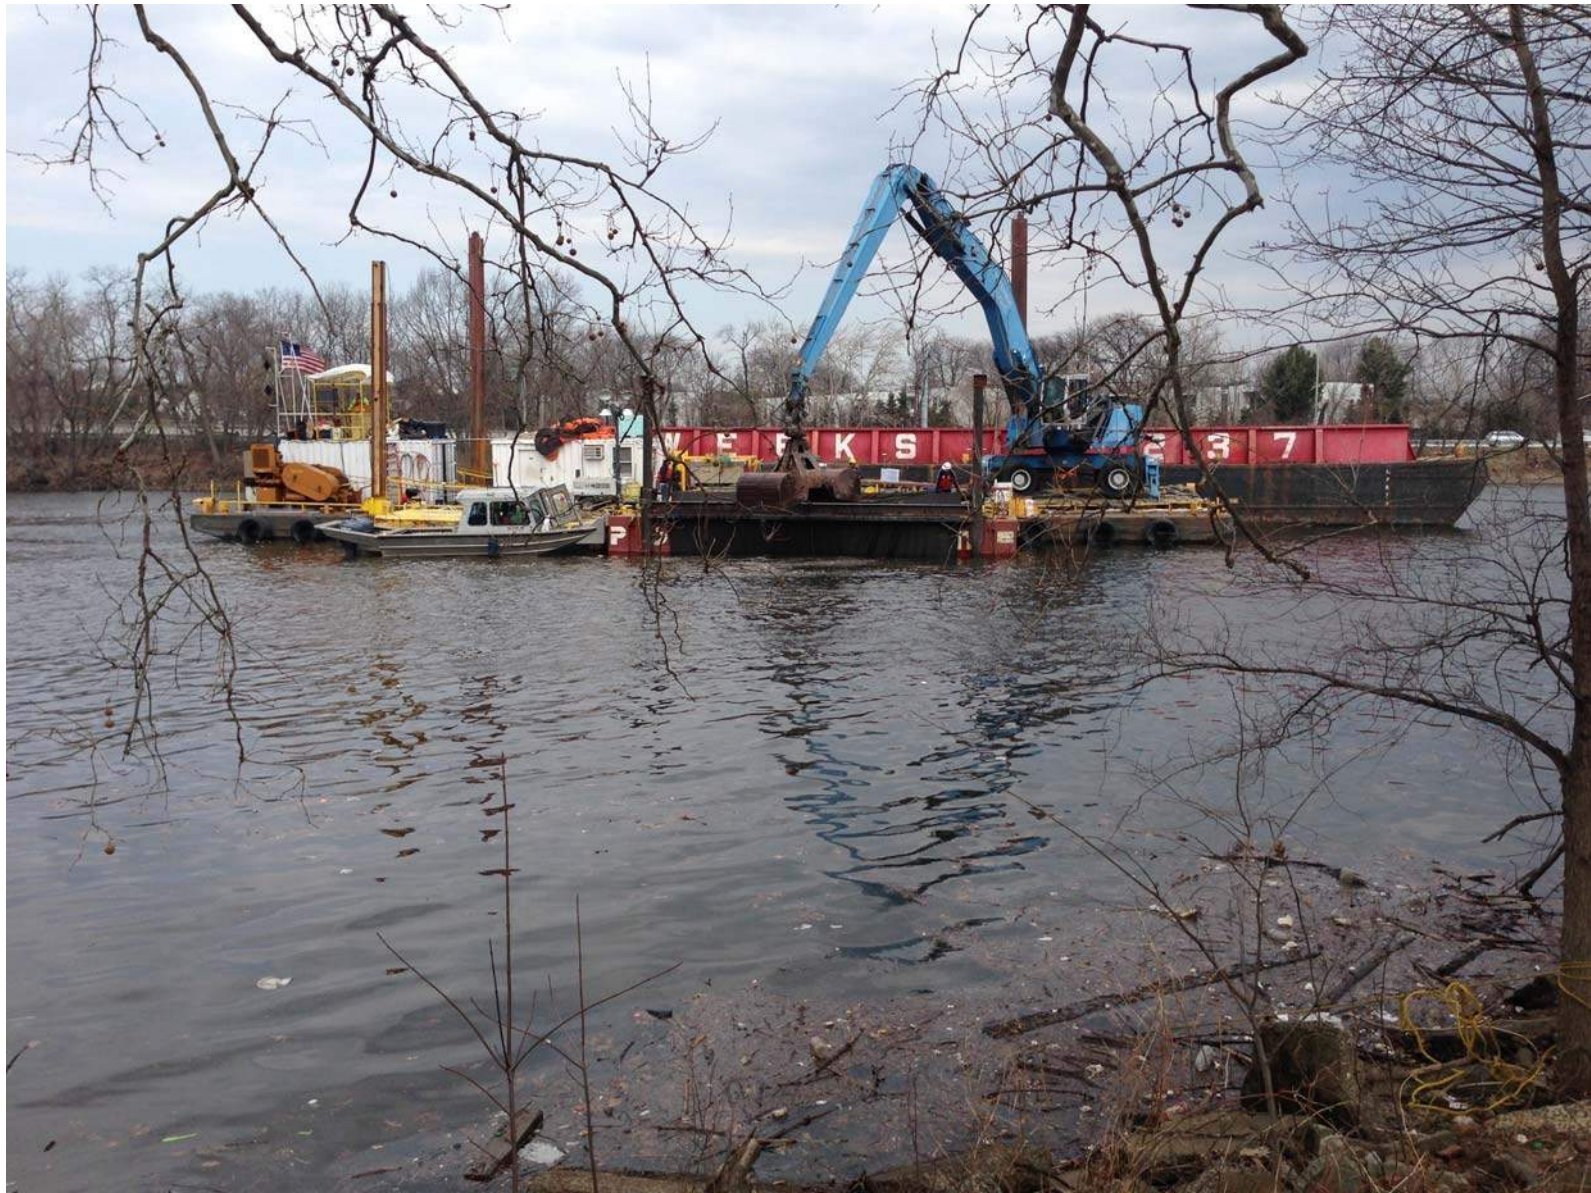
Panel 7-N Installation

This geotextile panel was installed in slightly over an hour. GLDD were able to maintain sufficient overlap between Panels 7-N and 8-N.

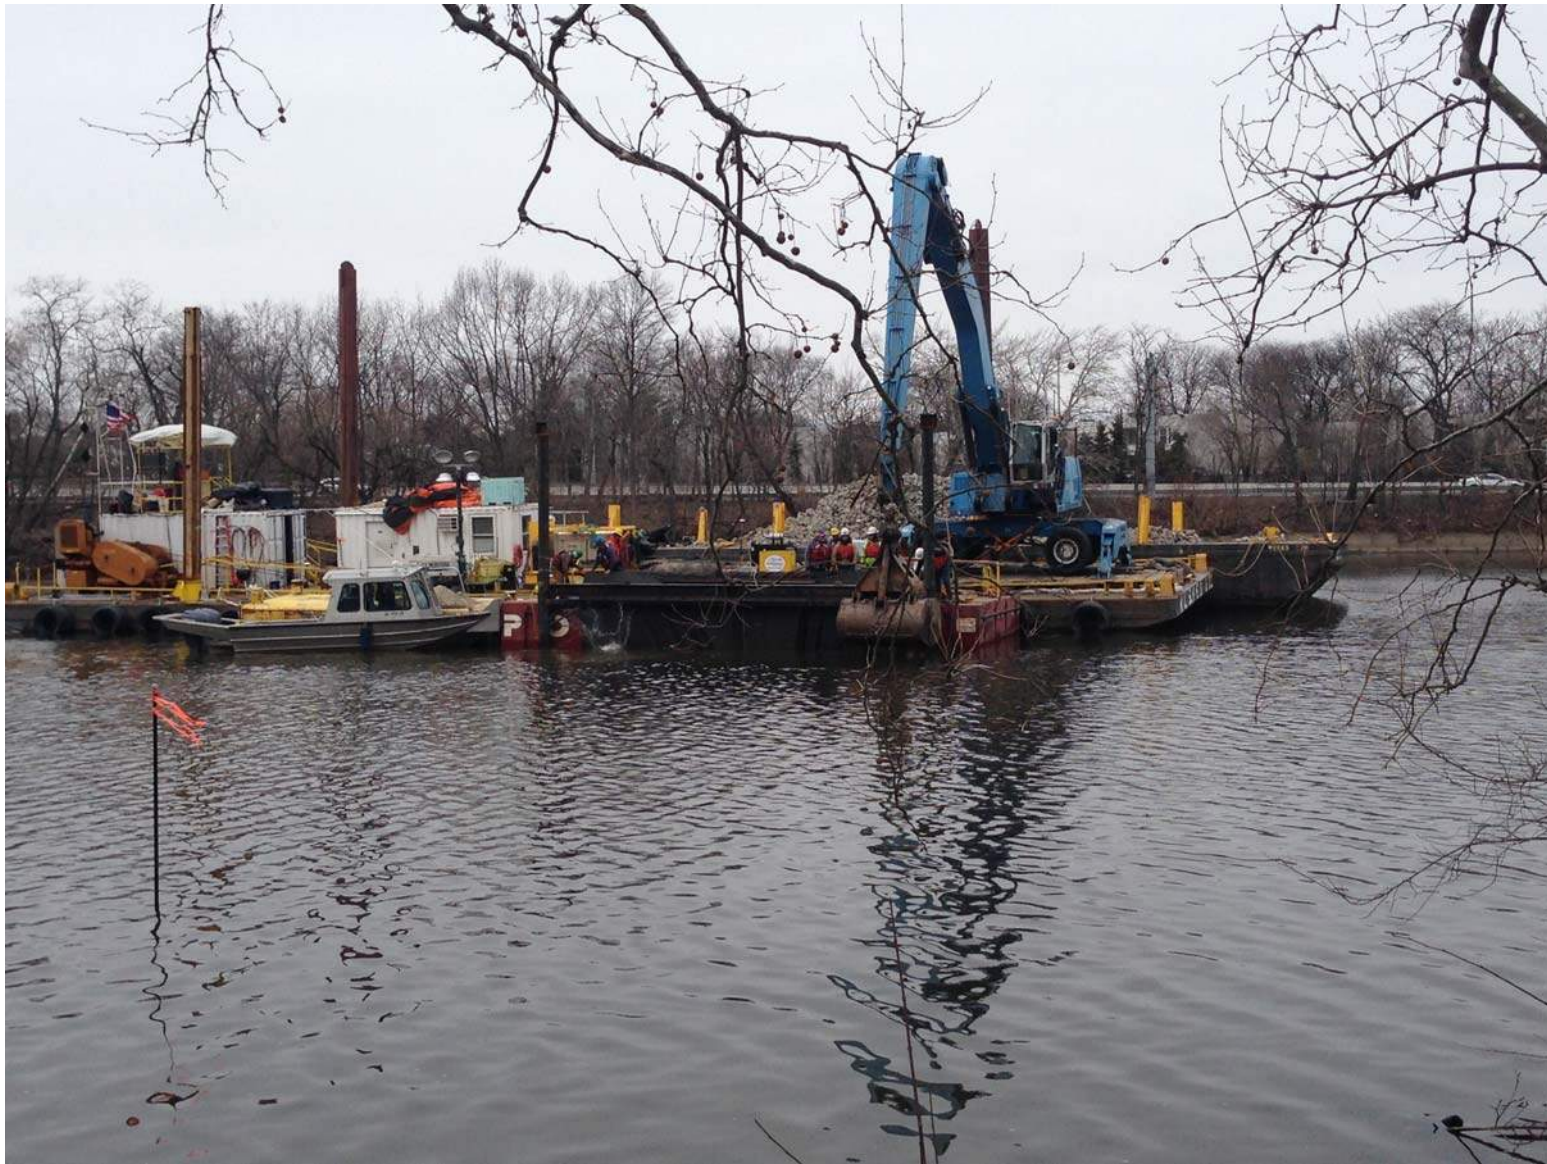
Panel 6-N Installation

GLDD are on pace to complete geotextile panel installation north of the No-Dredge Zone in the next week.
